Executive Summary

TRMM Flight Operations Team Systems Engineers

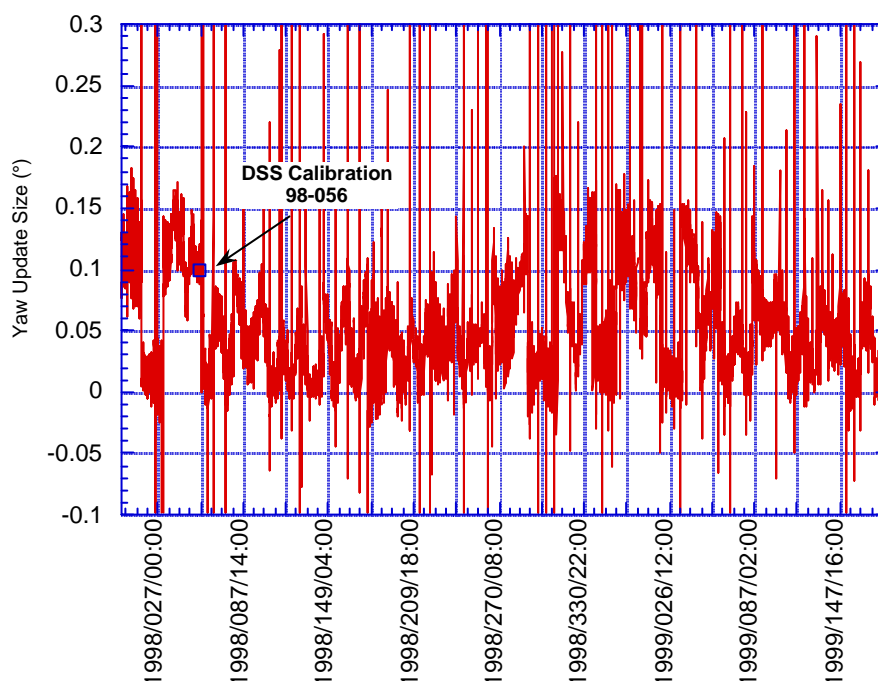
Figure 4.1-1 Maximum Yaw Updates

At the beginning of 1999 however, it was noticed that the yaw updates were getting larger again (see Figure 4.1-1). Recent trending has shown that the size is influenced by the seasons and direction of flight (larger in +X direction). During the time Yaw updates were large, the pointing accuracy violated the $1\text{-}\sigma$ pre-launch constraint. Analysis

showed that further DSS calibrations would have minimal effects, because irregular behavior of the ESA Offset Radiation Source (ORS) may be the significant contributor.

A Contingency mode version of the DSS table (#64) has been created and tested by FSW for uplink if needed.

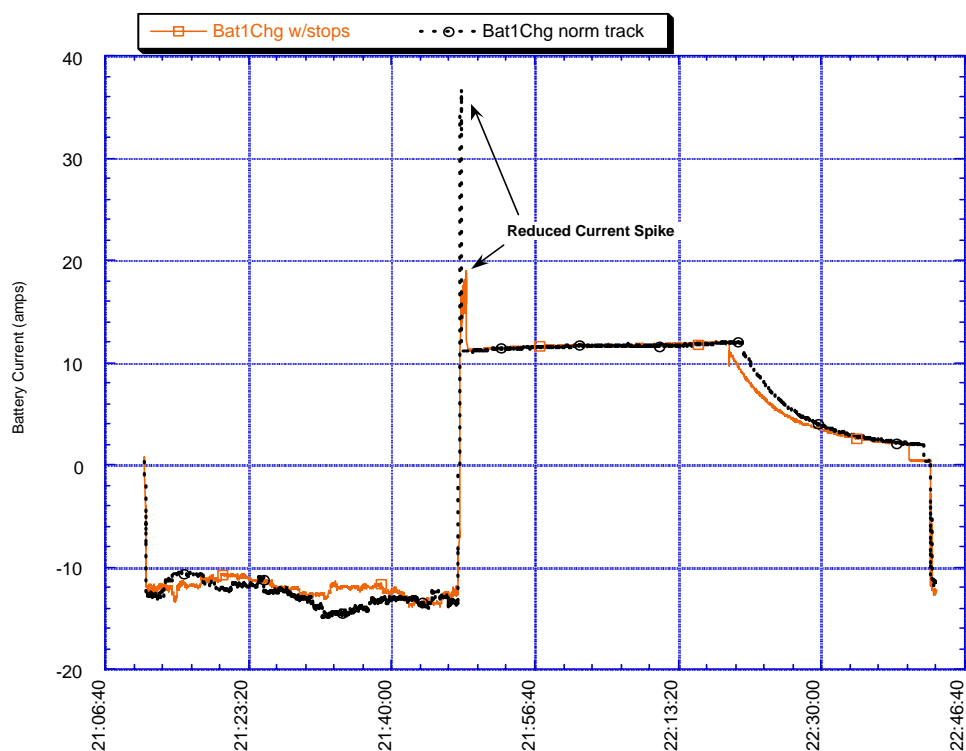
Figure 4.4-4 Charge Cycle at Beta 0° on 98-146

On 98-146 at 15:32 the solar array software stops were changed to $\pm 50^\circ$, and on 98-147 at 21:40 the stops were returned to the original $\pm 130^\circ$ (see Deployables section). Figures 4.4-4 and 4.4-5 show the charge cycle with the stops in place versus one at the same Beta angle without the stops. The stops seem to increase the discharge time by only a few seconds, and there is also a decrease in the spike seen at the beginning of the charge period prior to the SPRU regulation.

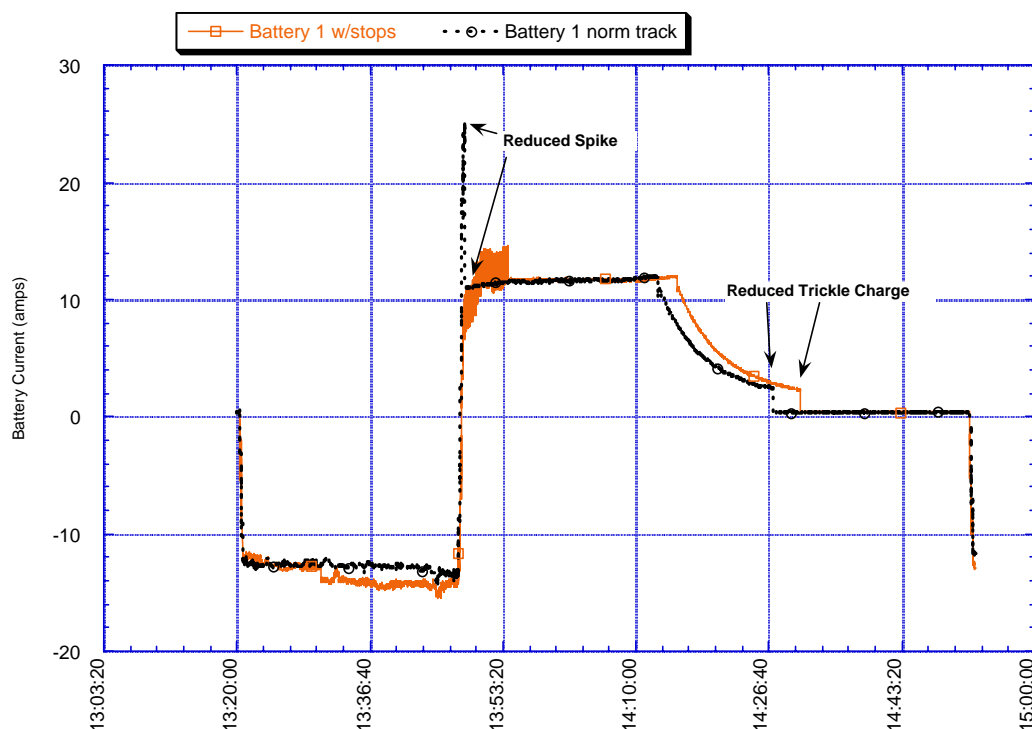
Figure 4.4-5 Charge Cycle at Beta 58° on 98-161

On 98-161 at 13:33 - 15:10, the solar array software stops were loaded again to observe the effects on the charge cycle at Beta $+58^\circ$, the worst case shadowing and incidence angle with the solar arrays. As Figure 4.4-5 shows, the current was at the 12 amp setting within 40 seconds. The orbital eclipse, or discharge period, is increased by approximately 30 seconds, and the trickle charge time is reduced by 3.5 minutes. The reduction of trickle charge time is inconsequential at the high Beta angles, since there is nominally 20 to 25 minutes of trickle charge time.

On 98-349, the $\pm 50^\circ$ solar array stops were loaded permanently. The PSIB solar array temperature threshold was reduced to 32°C , to more accurately match the cooling of the solar arrays from orbit day to eclipse with the reduced range of motion. Since the solar arrays have been limited, the Power system has performed nominally.

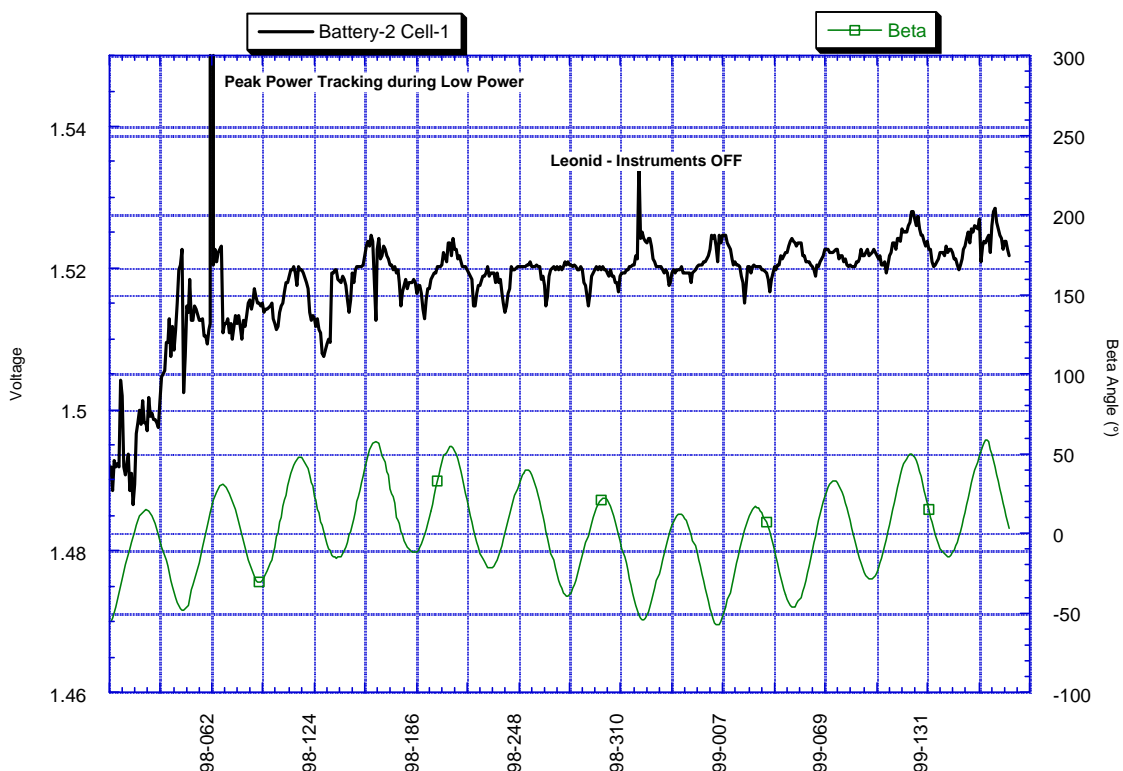
Figure 4.4-7 Battery-2 Cell-1 Voltage in Relation to Beta Angle

On 98-028, Battery-2 Cell-1 voltage began hitting the YH limit (Anomaly #55) of 1.49 volts. The cell charges 'in family', along with other nearby cells, until it approaches the V/T limit. As the V/T limit is approached, the cell diverges sharply upward and reaches its peak in conjunction with the V/T limit. Once the limit has been reached, the cell returns to the charge cycle 'in family'. See Figure 4.4-1 for a typical orbit profile of Battery-2 Cell-1 when compared to other battery cells and Figure 4.4-2 for the trend of daily maximum cell voltages.

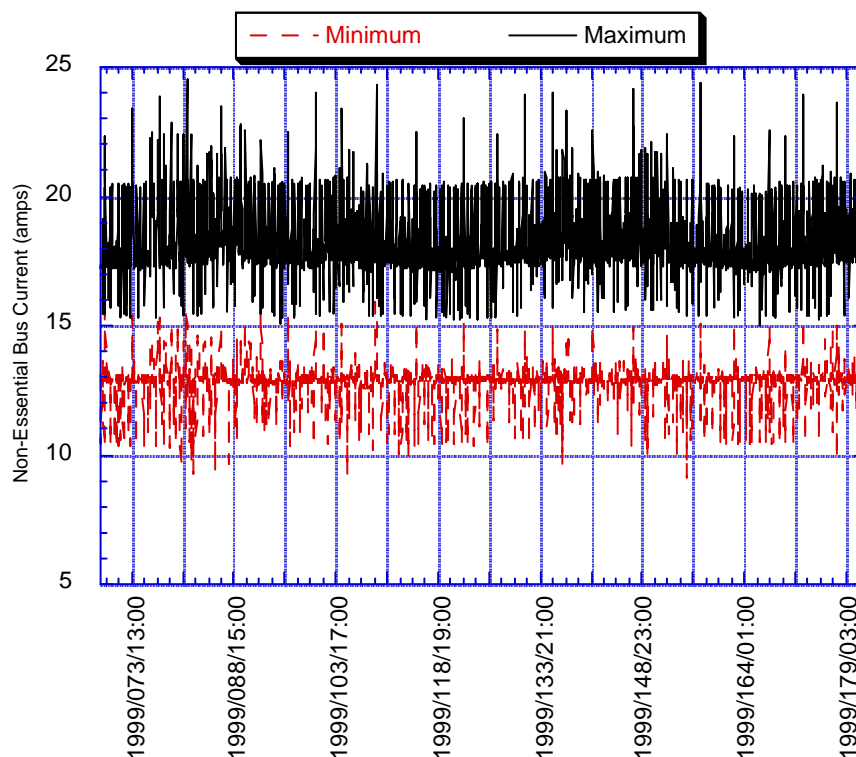
Figure 4.5-1 Non-Essential Bus Current

The Non-Essential bus current remains stable with an average current of approximately 16.7 amps. The average maximum current is about 22.5 amps with peaks of up to 24.8 amps, as shown in Figure 4.5-1. The maximum current peak is higher than the YH limit of 25 amps, but lower than the 50 amps Red High (RH) limit. This violation of the YH limit corresponds to days on which Delta-V maneuvers are performed at certain Beta angles; the Catbed heaters draw current from the Non-Essential bus.

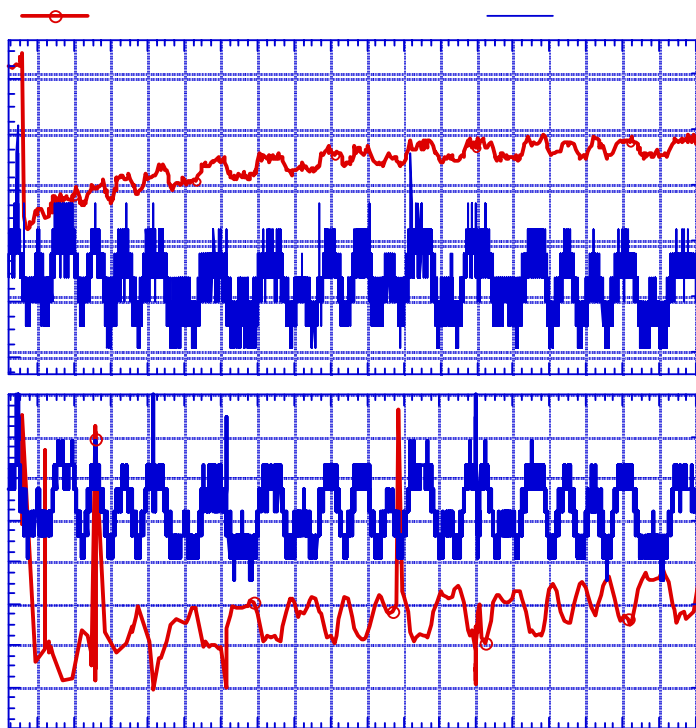
Figure 4.7-1 Transponder Frequency Behavior

The uplink frequency remains 207694254 dHz. Thus far, the updates to the NCC database in January 1998 have been the only required ground frequency adjustments; performed to account for the aggressive behavior of XP-1. The XP-1 frequency has recently settled to approximately 700 Hz ahead of the uplink, drifting a total (excluding adjustment) of 1700 Hz. XP-2 has been gradually approaching the uplink, now approximately -700 Hz. The frequencies exhibit a strong dependence on the Temperature Compensated Crystal Oscillator (TCXO) temperature (see Figure 4.7-1). The reason for the larger variation of the XP-2 frequency is unknown at this time.

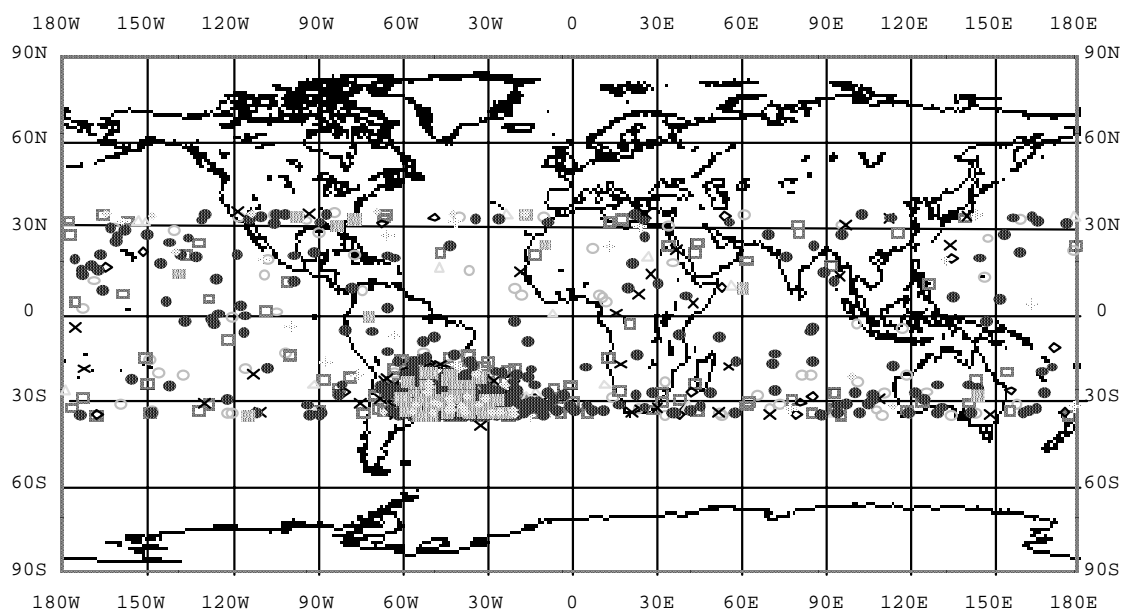
Figure 4.8-1 Geolocation of All 1773 Bus Retries

The 1773 optical busses have been experiencing an overall average of slightly less than three retries per day: the spacecraft bus (XS) experiences 1 per day, the instrument bus (XI) experiences 3 every 2 days, and the ACS bus (XA) experiences 1 every 4 days. Most retries have occurred in the South Atlantic Anomaly (SAA) Region (see Figure 4.8-1 for the geolocation plot) and none have resulted in any spacecraft anomalies.

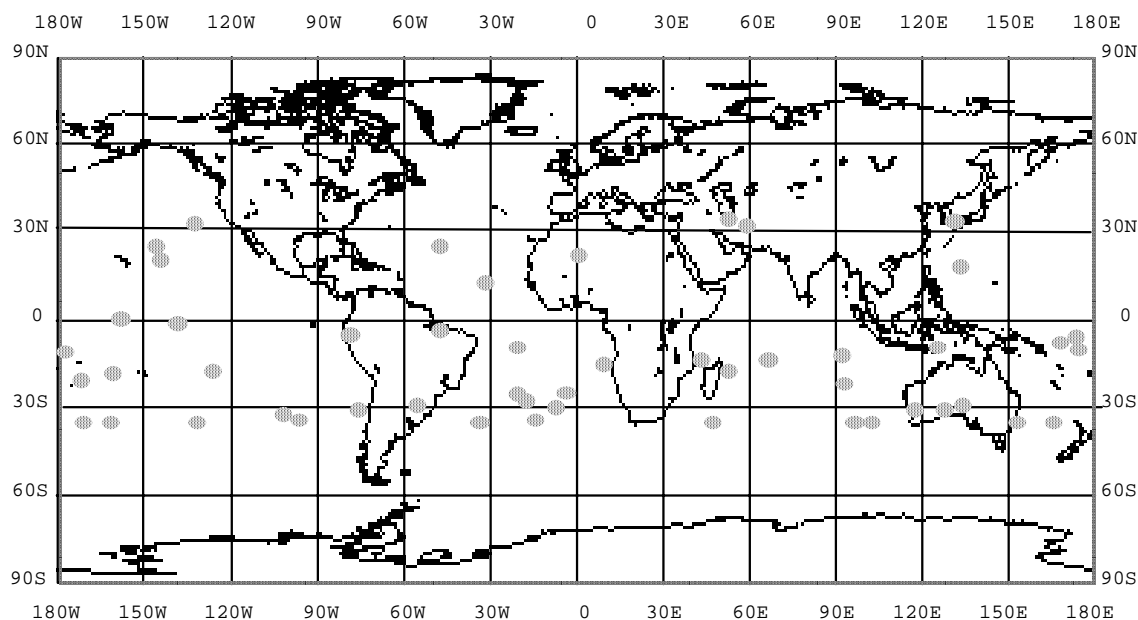
Figure 4.8-2 Geolocation of Flywheel Occurrences

The Time Code (TC) FLYWHEEL anomaly (Anomaly #51) still occurs regularly. This has had no apparent affect on operations to date and has not been experienced on the ACS processor. Most of the flywheels have occurred below the equator, with approximately half of all of them occurring in the lowest 10° of the orbit (25-35° Latitude) which seems to indicate some geolocation dependence (see Figure 4.8-2). These incidents also seem to occur in timing clusters, with several happening close in time and then stopping for a period. The cause has not yet been determined, but the behavior does not appear to be affecting any component of the spacecraft. Dwelling is being used to track the behavior. The spacecraft processor TC Correlation Flag also toggled to False for a single update (Anomaly #63). This is an expected occurrence and is believed to be related to the TC FLYWHEEL anomaly.

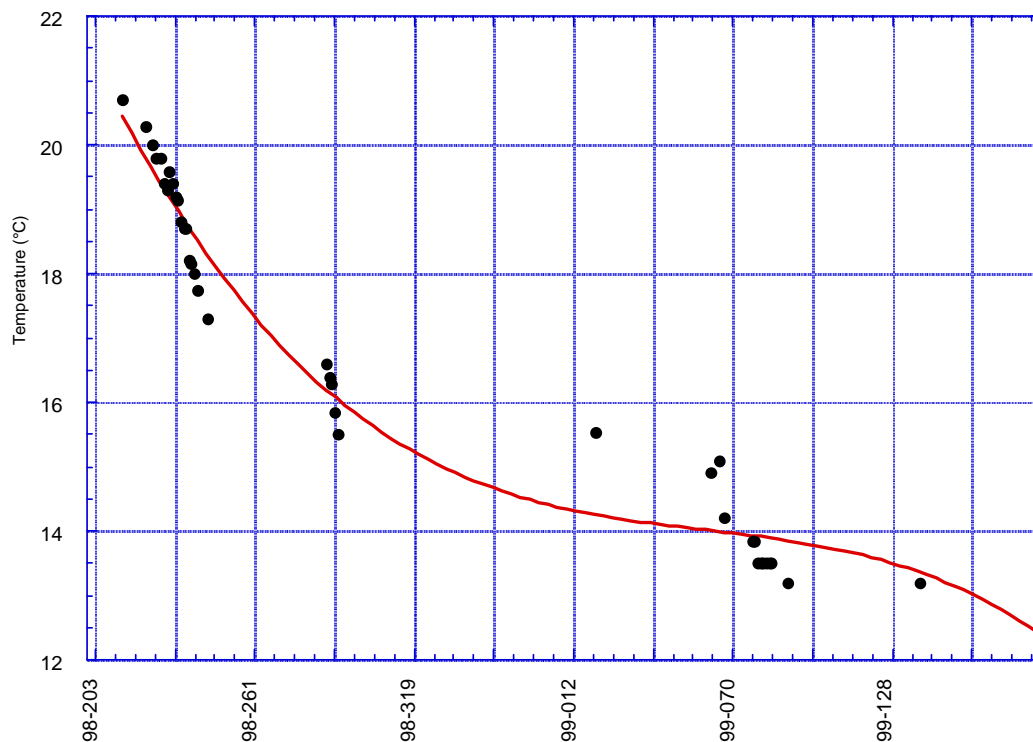
Figure 5.1-3 Motor Bearing Temp Threshold where Unregulation Begins

On 98-287 at 00:56, CERES was powered on to exercise several operations to characterize the behavior of the converter and gather more engineering data. Figure 5.1-2 shows how the converter voltage stops regulating as the motor bearing reaches a certain temperature. Figure 5.1-3 shows the degradation of the temperature threshold of the converter. TSMs #35 - 37 and RTS #34 were built and loaded on 98-260 to the spacecraft to monitor the converter and power the instrument OFF if the DAA voltage

CERES remained off for the remainder of 1998, while the Langley Tiger Team assessed the behavior and cause of the voltage converter anomaly. The voltage converter starts going out of regulation at a temperature that can be assessed using the motor bearing telemetry. The temperature limit for regulation decreases with time and use of the instrument. The results from the engineering test confirmed that the converter's degradation behavior was well understood and that it did not affect the science or calibration data gathered. The conclusion was that there was enough regulation life in the converter to operate for important field tests and eventually power on permanently after the Terra launch.

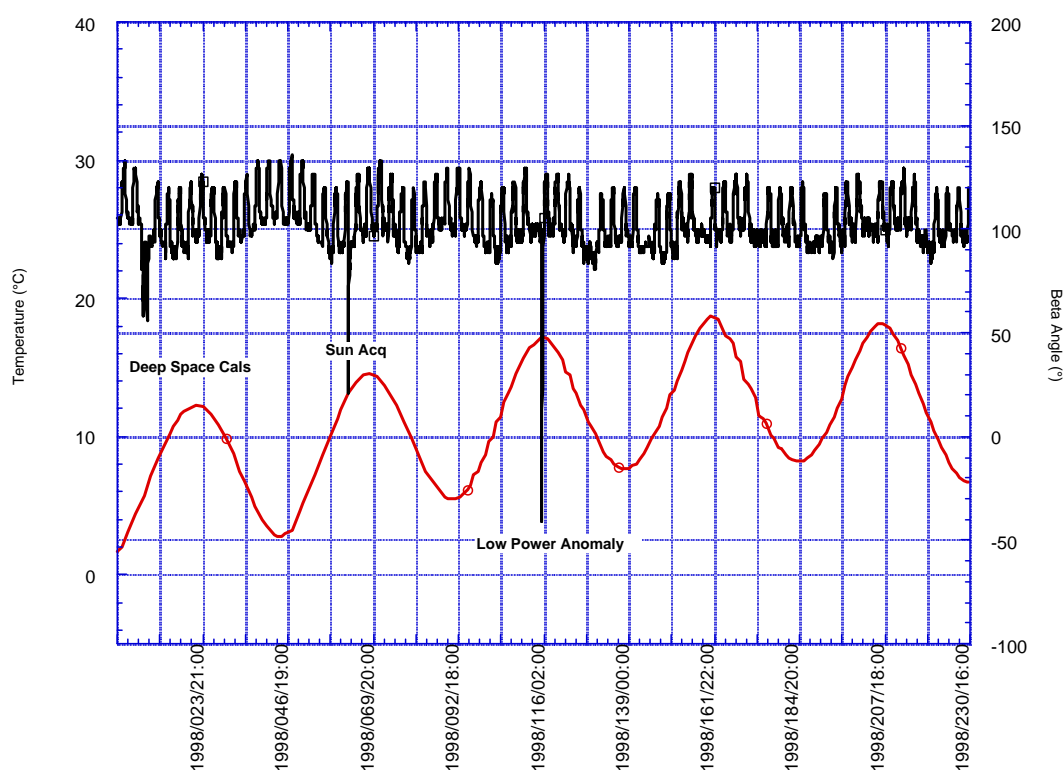
Figure 5.1-4 PCA Radiator Temperature and Beta Angle

All temperatures and voltages, with the exception of the DAA +15V converter, have been as expected and within limits. Most of the temperatures vary with Beta angle, such as the Power Converter Assembly (PCA) Radiator temperature that varies between 22.9 °C and 29.9 °C, with the lower temperatures at Beta 0° (see Figure 5.1-4). The azimuth gimbal upper bearing temperature ranges from 19.45 °C to 27.6 °C at Beta angles greater than 50° and 16.92 °C to 23.7 °C close to Beta 0° (see Figure 5.1-5). The IPSDU total CERES current (the IPSDU-A current multiplied by two), shown in Figure 5.1-6, reached highs of 2.4 amps. The current ranges from 2.1 to 2.4 amps during Biaxial mode operations and ranges from 1.7 to 1.8 amps during Crosstrack mode. The currents are higher near Beta 0°.

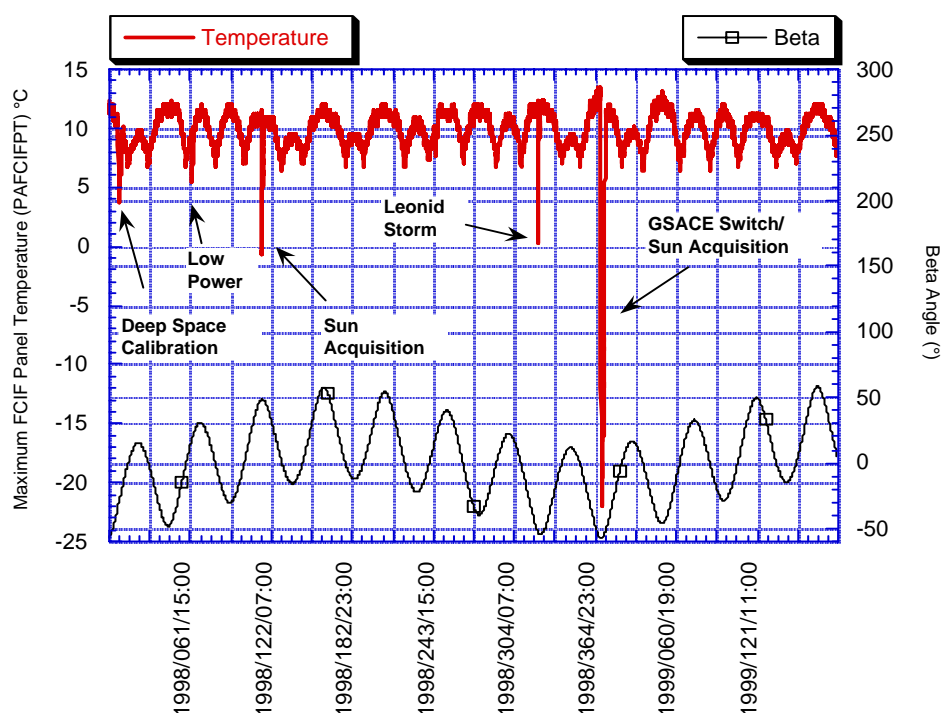
Figure 5.3-1 FCIF Panel Temperature and Beta Angle

All PR temperatures and currents have remained within limits, even during planned events like the Deep Space Calibrations and the Leonid Storm and anomalies like Low Power and Sun Acquisition. As shown in Figures 5.3-1 through 5.3-3, the panel temperatures have fluctuated with the Beta angle. The peaks for the FCIF have corresponded to a Beta angle of $\pm 58^\circ$, while the peaks for the SCDP and Power Supply

have corresponded to a Beta angle $\pm 30^\circ$. The lows for all three temperatures have corresponded to a Beta angle of 0° because the spacecraft body insulates PR from the Sun when it is overhead. The maximums for the FCIF, SCDP, and Power Supply panel temperatures are 9-12 $^\circ\text{C}$, 17-18 $^\circ\text{C}$, and 7-9 $^\circ\text{C}$, respectively. The minimum temperatures are not displayed on the figures but are within a couple of degrees of the maximums for all three panel temperatures. The coldest that all three temperatures have been was during the GSACE/Sun Acquisition anomaly on 99-003, due to the length of time that the instrument was powered off. These temperatures were -23 $^\circ\text{C}$ (FCIF), -19 $^\circ\text{C}$ (SCDP), and -17 $^\circ\text{C}$ (Power Supply) and approximately correspond to the thermostat close setpoint for each of the three heaters.

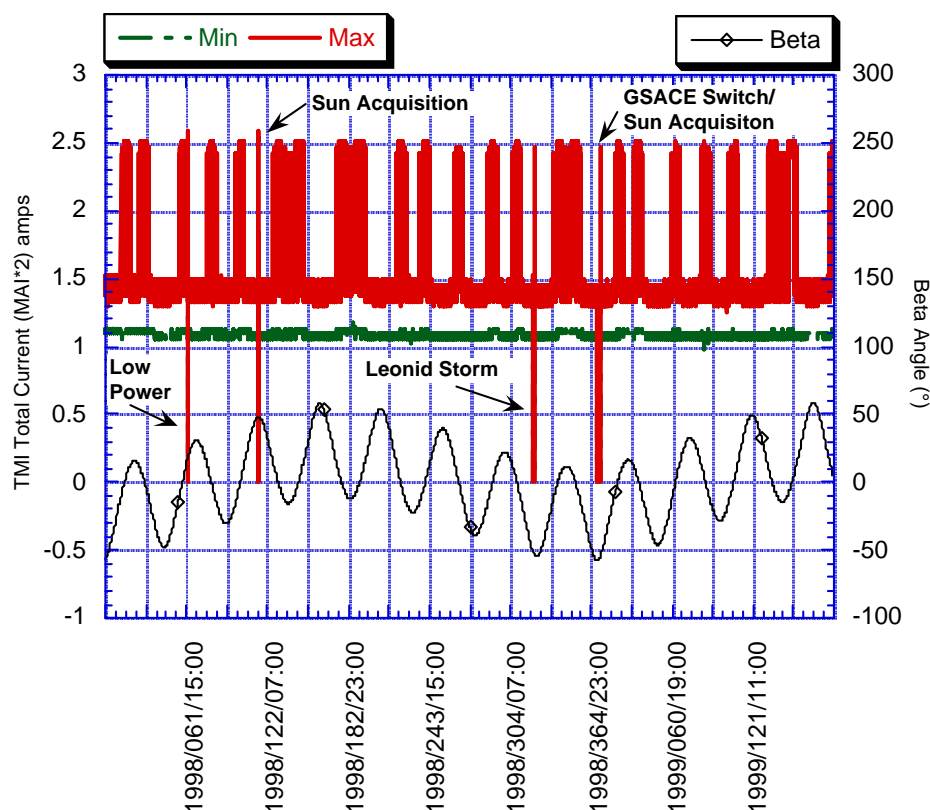
Figure 5.4-1 TMI Current and Beta Angle

The instrument current has remained well within limits (YH is 2.8 amps). As shown in Figure 5.4-1, the IPSDU total TMI current (the IPSDU-A current multiplied by two) reached highs of 2.5 amps. The current draw reaches its highest level around a Beta angle of $0^{\circ} \pm 18^{\circ}$, which corresponds to the BAPTA heater turning on and off. The setpoints of the BAPTA heater are 3 °C ON and 9 °C OFF.

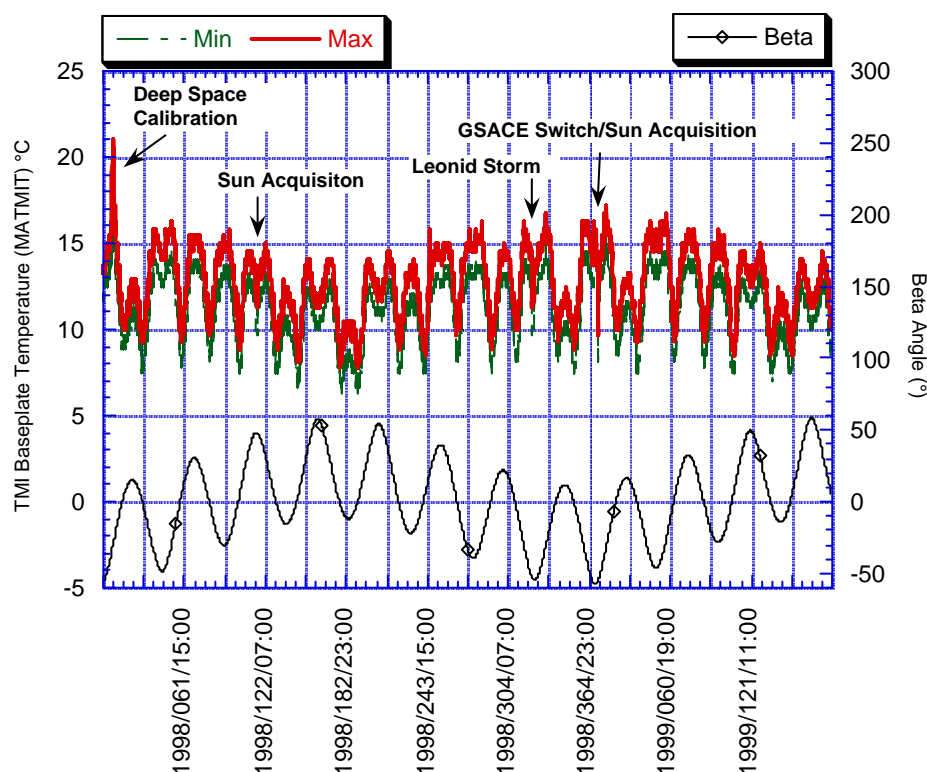
Figure 5.4-2 TMI Baseplate Temperature and Beta Angle

The baseplate temperature has stayed within limits during the two extreme Beta angles of $+58^\circ$ and -58° . It peaks at a Beta angle of $\pm 35^\circ$ and hits lows at Beta angle 0° (see Figure 5.4-2). The temperature peak occurs at Beta $\pm 35^\circ$ instead of the two extremes because of the way the Sun heats TMI (more directly instead of edge-on). The temperature reached its highest point during the Deep Space Calibration in January. Temperatures also display higher values in the negative Beta range, which is due to the direction of flight; TMI in back or front.

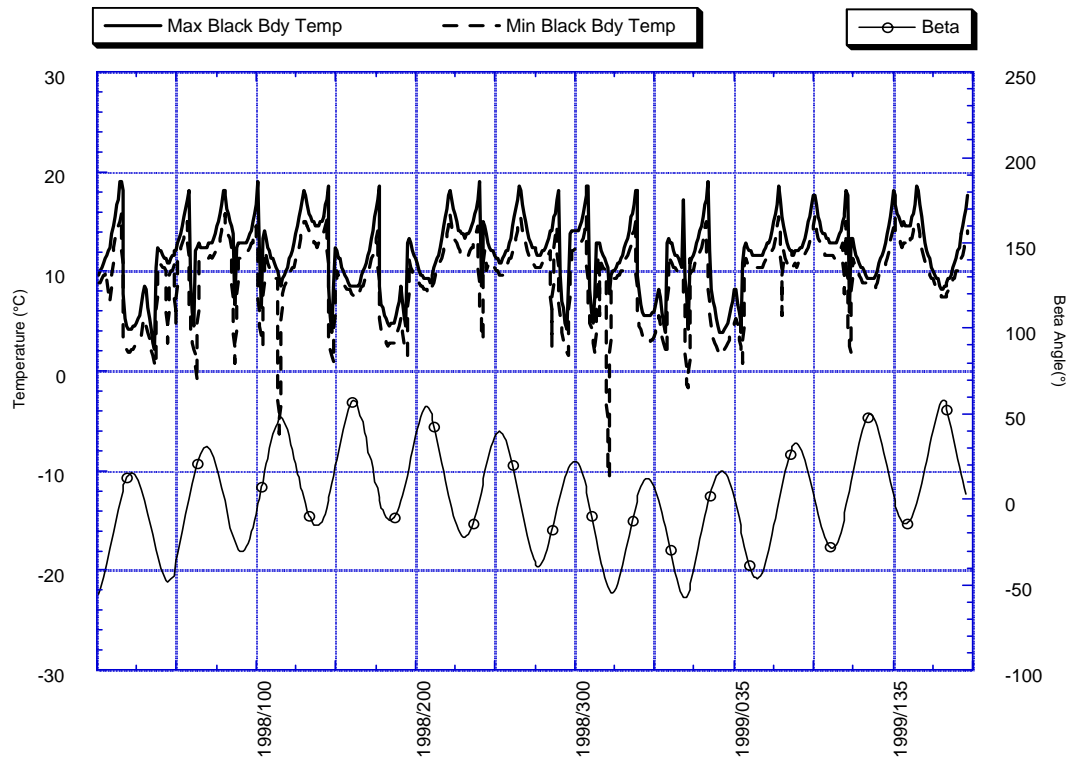
Figure 5.5-1 VIRS Blackbody Temperature and Beta Angle

The housekeeping data shows that all parameters (currents, voltages, and temperatures) are within expected ranges. The scanner module blackbody temperatures are maintained within the 0 °C to 20 °C calibration range by using the 8.5 W and 15 W heaters (see Figure 5.5-1). The heaters are operated through ground commands. The ground system configuration monitor (Configmon) generates messages when the heaters are approaching their set limits. Although the power supply temperature is within limits, it has operated up to 42 °C (YH limit is 45 °C), as shown in Figure 5.5-2. The power supply temperature can be reduced when necessary, by reducing the use of the 15 W heater.

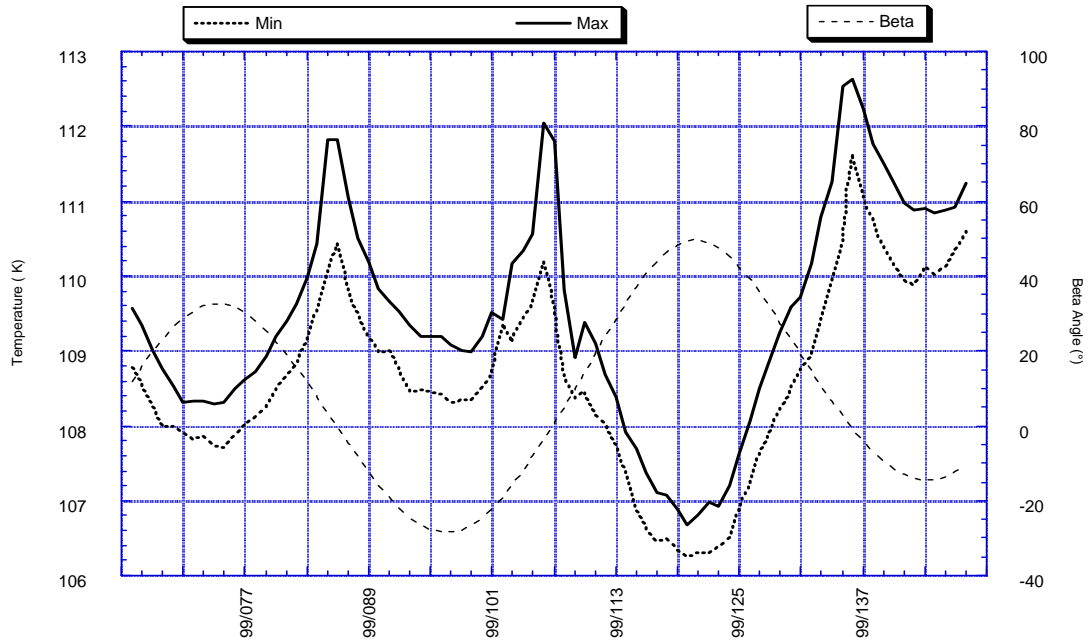
Figure 5.5-3 Cold Stage Temperature and Beta Angle

Many housekeeping mnemonics are trended on a weekly basis. The Cold Stage temperature varies by approximately 7 K depending on the Beta angle. A variation of 0.5 K is also seen between orbital eclipse and daylight (see Figure 5.5-3). The Intermediate Stage temperature has also been found to be Beta angle dependent, and the temperatures vary between 160 K at Beta 0° and 154 K at Beta angles above/below $\pm 15^\circ$ (see Figure 5.5-4).
